Analysis Report

Component Information			Sample Information			Customer Information		
Machine Type:	Low Speed Diesel	Sump Size: 5,320	Received:	12/15/2015	R-5 - Ship A-201			
Lubricant:	MOBIL/Mobilgard 300		Report:	12/15/2015	Port Example			
Machine MFG:	SULZER		Sample No.:	2695 - 2 - 1 - 17	Baltimore, MD			
Machine MOD:	6RND90		Data Analyst:	DR	Contact: Jack Boilerman

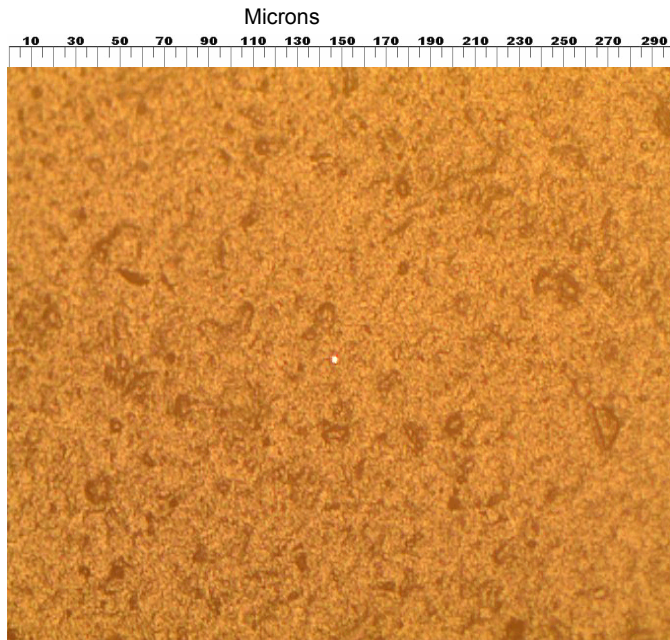
Observations: Analytical microscopy has discovered the following abnormalities. High levels of dust and dirt. Excessive dust and dirt particles are the result of external contamination. These are usually airborne and the result of open hatches, failed seals, poor filtration and inadequate breathers.

100x Rubbing wear debris & dust/dirt.

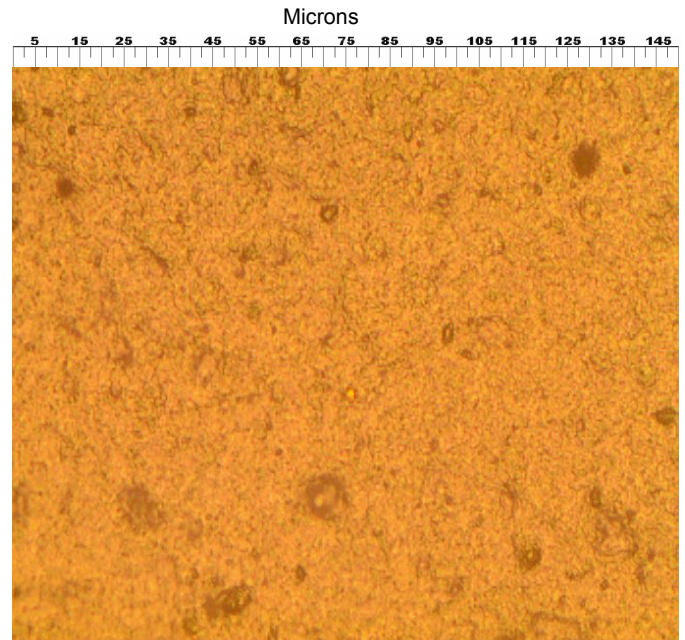
200x Rubbing wear debris & dust/dirt.
