Analysis Report

Component Information			Sample Information			Customer Information		
Machine Type:	Low Speed Diesel	Sump Size: 5,320	Received:	12/15/2015	R-5 - Ship A-201			
Lubricant:	MOBIL/Mobilgard 300		Report:	12/15/2015	Port Example			
Machine MFG:	SULZER		Sample No.:	2695 - 2 - 1 - 17	Baltimore, MD			
Machine MOD:	6RND90		Data Analyst:	DR	Contact: Jack Boilerman

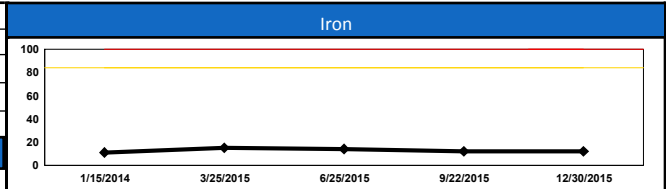
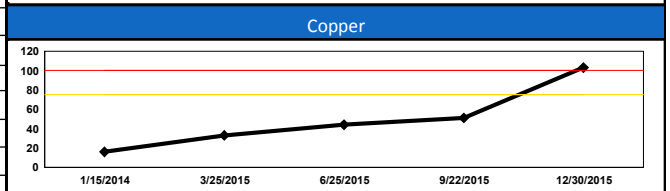
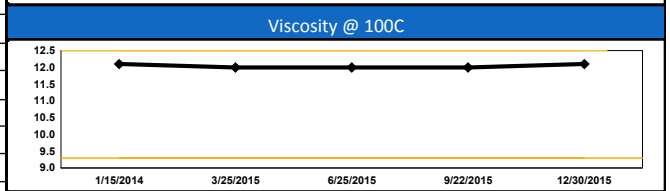
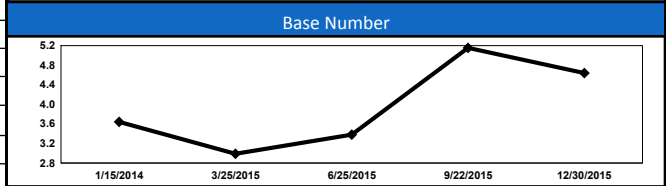
PROBLEMS
 HIGH COPPER.
 Low VISCOSITY 100C
 EXCESSIVE FUEL DILUTION

COMMENTS Elevated wear metals may indicate accelerated machine wear. Inspect unit for abnormal noise, vibration and high temperature.
 The viscosity is out of range due to excessive fuel contamination in the fluid. Fuel dilution level is above acceptable limits. Locate source of fuel leakage or possible cause of contamination prior to changing oil.

Date	Customer Corrective Actions
1/13/13	re-sample; Possibility of switched sample warrants resampling.
