Material Identification Analysis

Machine Type:	Hydraulic System	Received:	01/18/16	ATTN: Insight Services
Lube Type:	Mobil Hydraulic AW 68	Report:	01/27/16	20338 Progress Dr.
Machine MFG:	Unknown	Lab No:	914344	Strongsville, OH 44149
Machine MOD:	Unknown	Analyst:	HS	(216) 251-2510
Sample Source:	Bottom

A sample of sludge-like debris from a hydraulic system was submitted for characterization.

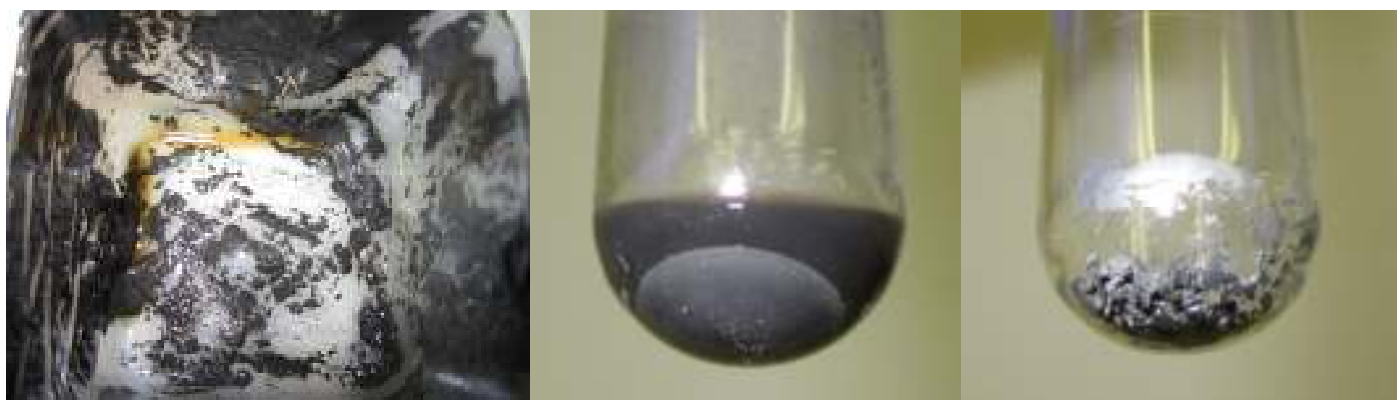
The sample was washed with pentane and extracted in methylene chloride to produce two fractions: methylene chloride soluble and methylene chloride insoluble.

Fig. 1 (From left to right) sample as received, soluble and insoluble fraction, insoluble fraction.

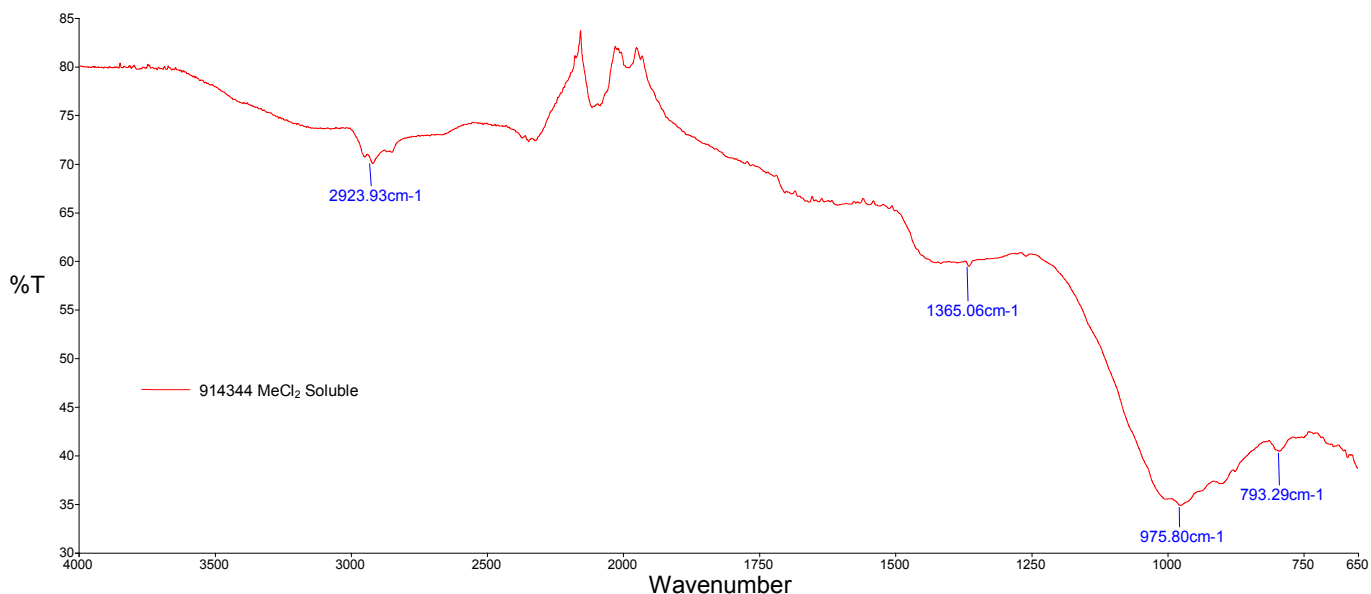
The methylene chloride soluble portion, or organic portion (red spectrum), exhibited a dark brown color. The FTIR spectrum showed very little organic material was present as observed by the peak found at $\sim 3000\text{cm}^{-1}$ as well as the absence of a peak at 1460cm^{-1} . The main chemistry observed were phosphates seen at 975cm^{-1} .

Fig. 2 Methylene chloride soluble fraction.

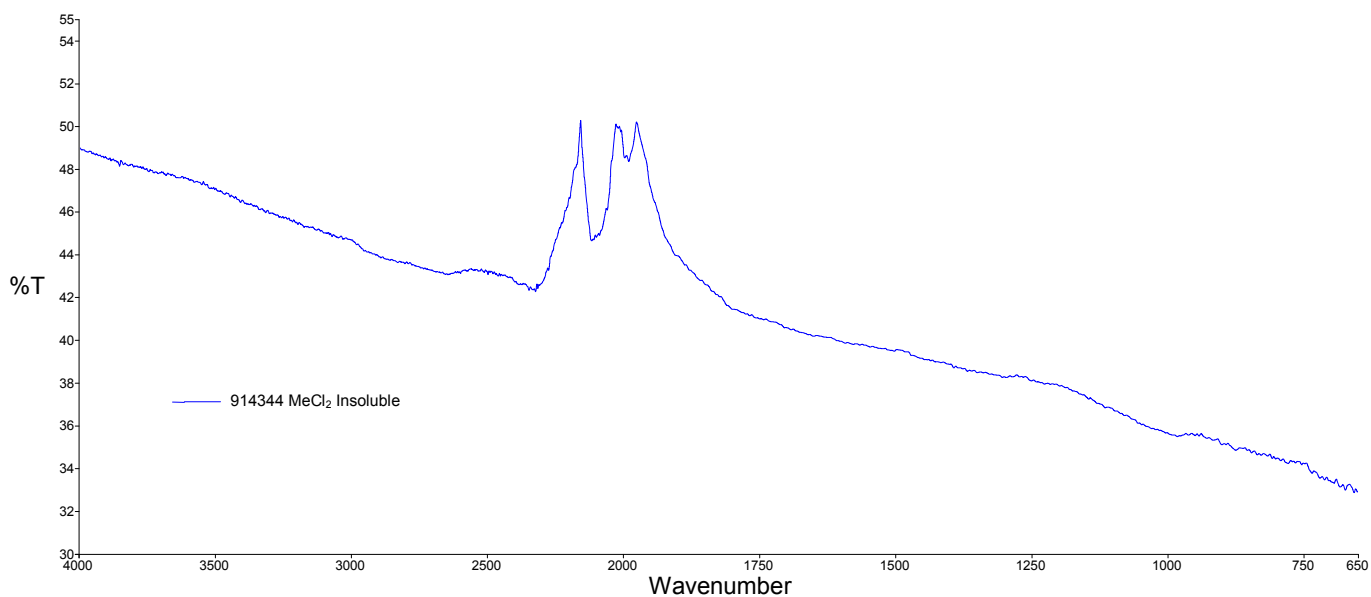
The methylene chloride insoluble sample, or inorganic portion (blue spectrum), exhibited a grey/black color. The grey color indicates metals which cannot be observed using FTIR spectroscopy. The black color will indicate black-body particles which will completely absorb in the spectrum, and have a propensity to scatter infrared light causing a depression in the baseline of the FTIR spectrum. In this case the depression occurs across the entire spectrum beginning at 49% transmission and ending at 33% transmission. Transmission indicates the intensity of infrared light that has passed through the sample compared to the intensity of light when it entered the sample. No chemistry could be observed due to the black-body absorbance. Therefore, testing used to verify the presence of soot and metals followed.

Fig. 3 Methylene chloride insoluble fraction.

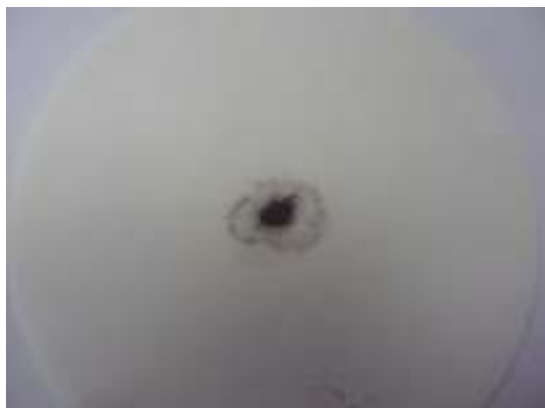
Filter paper chromatography was used to verify the presence of soot as the black-bodied particles. A portion of the sample was placed on filter paper, and then was eluted with toluene to reveal the true color. The chromatogram showed finely divided material seen at the center of the sample, and surrounding black color indicating soot.

Fig. 3 Chromatograph of the soot.
